IMPERIAL COLLEGE LONDON

Department of Civil and Environmental Engineering

**Assessing the applicability of CPT and
Piezocone tests for identifying the presence of
fault damage zones on geotechnical
engineering projects**

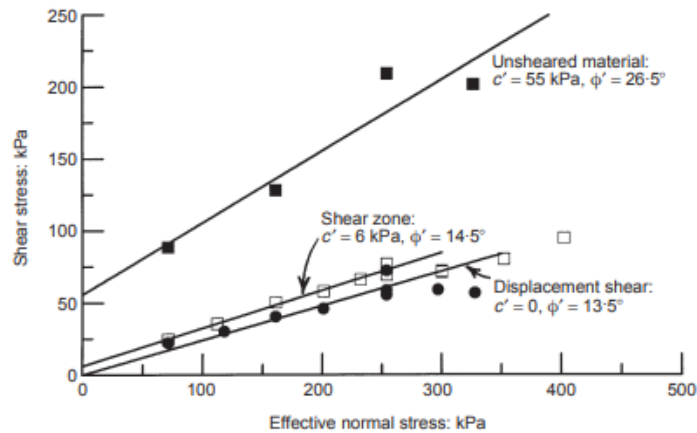
Chandler et al. (1998): Highlighted the fact that unsheared clay has relatively higher shear strength compare to clay samples retrieved from a shear zone (See Figure 2.1).

Figure 2.1: Shear strength intact and reworked London Clay by Chandler et al. (1998)

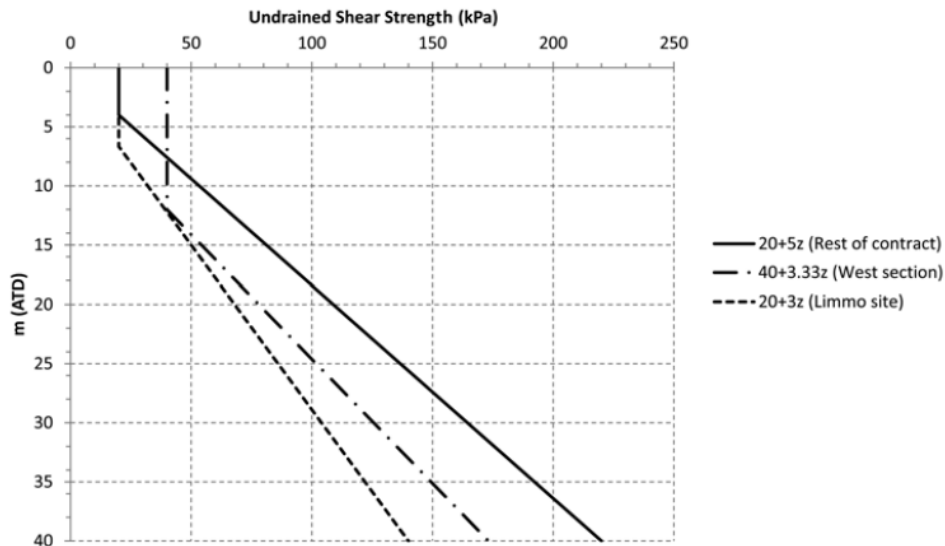
Linde-Arias et al. (2017): Reported that the values of undrained shear strength for London Clay at the Limmo site (where faults were identified) were lower compare to other sites where faults were absent (See Figure 2.2).

Figure 2.2: Undrained shear strength obtained for Limmo site, and for all other Crossrail sites by Linde-Arias et al. (2017)

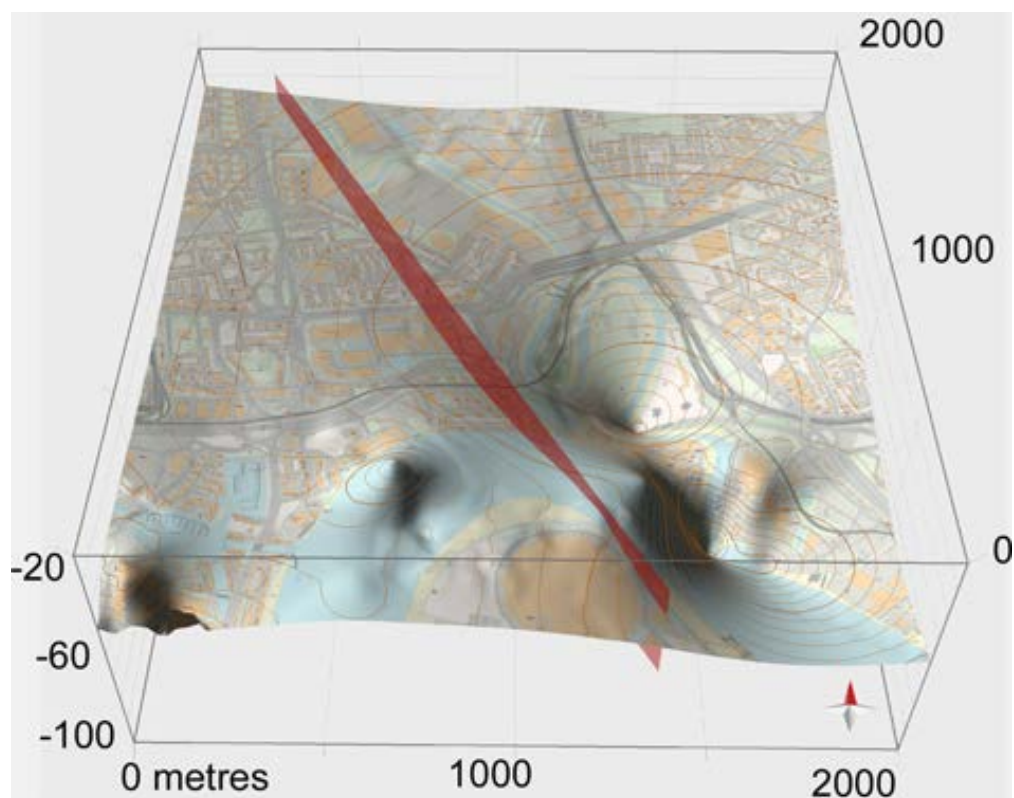
As it was pointed out by Linde-Arias et al. (2017), exceptionally low values of undrained shear strength were found in the London Clay of the Limmo Peninsula, which Linde-Arias et al. (2017) interpreted as a result of tectonics. This peninsula encompasses several drift filled hollows, aligned with rock outcrop on the upper Chalk surface as shown in Figure 2.7, these depressions can reach up to 70 m deep filled with transported material. Their origin may be associated to fluvial scour and pingo formations. Two major drift filled hollows are presented in Figure 2.7, that Linde-Arias et al. (2017) described as “releasing-bend flower structures” given rise to “transtensional basins”.

Figure 2.7: Sinistral wrench fault, Upper Chalk surface and Drift filled hollows by Linde-Arias et al. (2017).

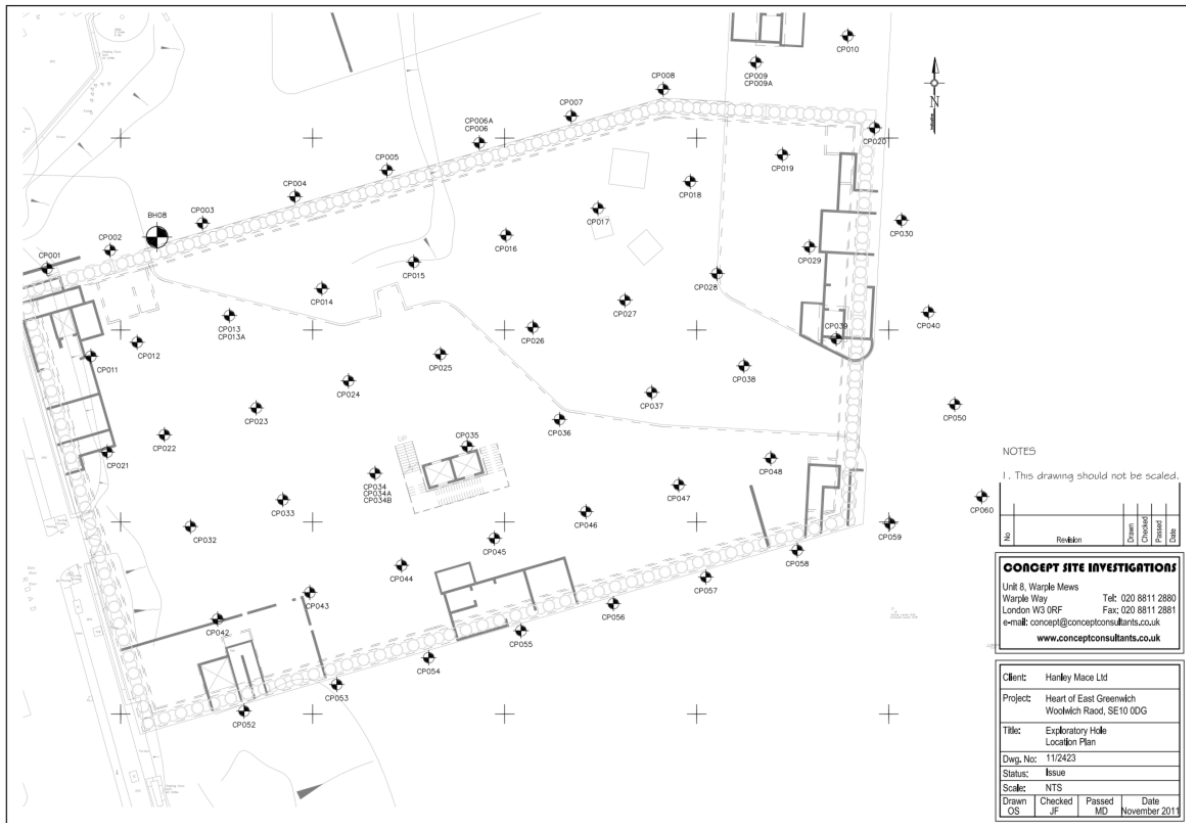
56 CPT, and 9 Piezocone tests were carried out by a subcontractor employing a UK17, a truck mounted CPT unit with an ultimate reaction frame of 33,0 ton capacity. The tests were distributed in an square pattern of 10,0 m x 10,0 m over the study area. The plan view of the tests is shown in Figure 2.8. The maximum depth of exploration was 20.5 m, at CPT17. These tests were reported by Savvidou, O. (2012).

Figure 2.8: Plan view of CPT and Piezocone tests at the Heart of East Greenwich (Savvidou, 2012)

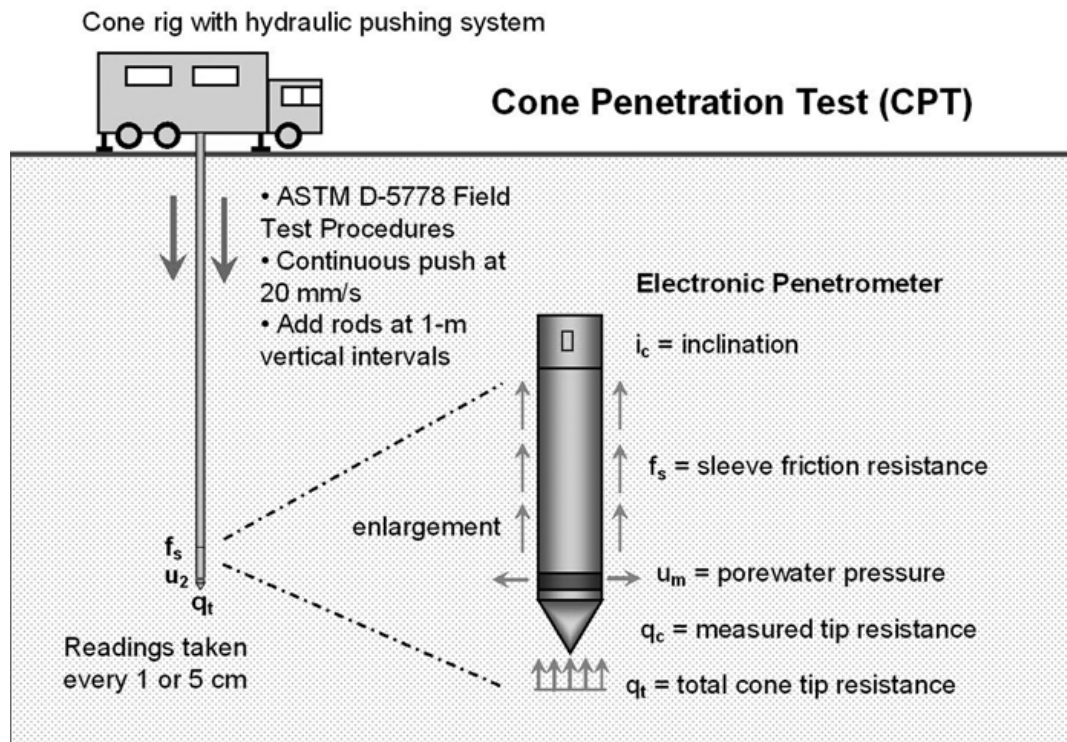
The cone penetration testing is a modern sounding technique, which usually involves pushing an electrical penetrometer, testing and recording continuously soil, as it goes down, usually at a rate of 2,0 mm/s, see Figure 3.1. According to international standards (i.e. ASTM D5778-12) three different parameters can be registered, these are: cone tip resistance (q_c), sleeve friction (f_s), and pore water pressure (u). Under some specific conditions sands or sandy fills can be traced just by using q_c and f_s , whereas for fine-grained soils pore pressures are required to better define soil stratigraphy. When pore pressures are registered, they must be used to correct the cone tip resistance and sleeve friction, by doing this soil properties can be derived, such as: undrained shear strength (S_u), lateral stress ratio (K_0), etc. (Mayne, 2007).

Figure 3.1: Cone penetration test per ASTM D5778 procedures by Mayne (2007).

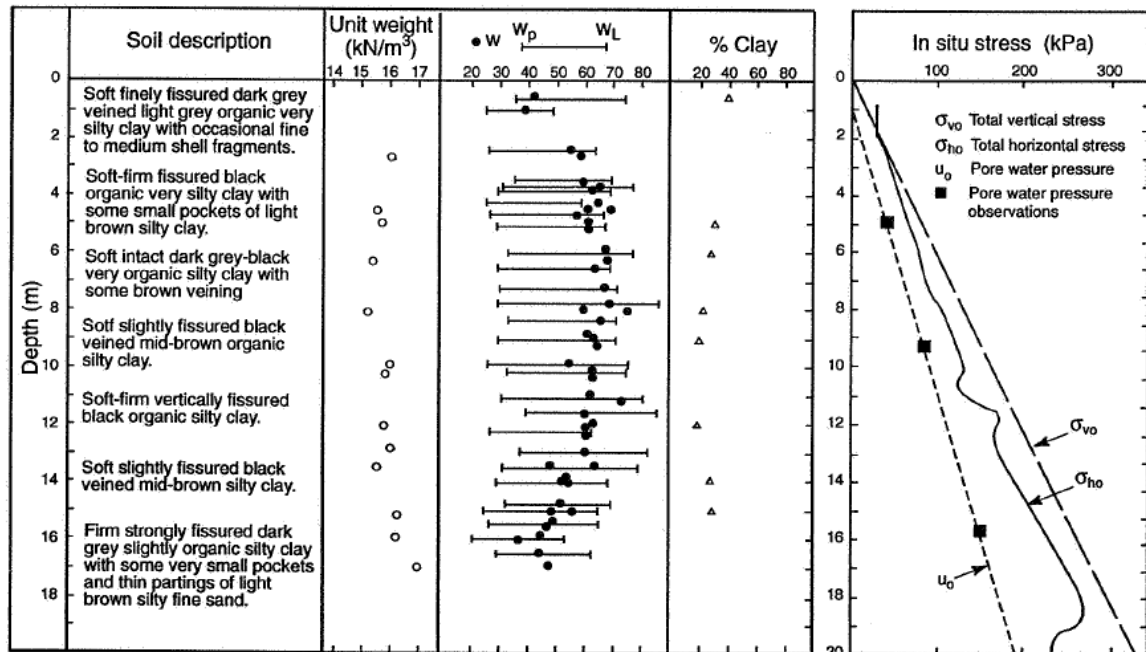
A typical ground profile of the site can be shown in Figure 3.8. It is clear that the water content increases with depth within the clay but decreases when approaching the coarse-grained deposit. The unit weight tends to increase with depth, and the percentage of clay content is characteristic of a clayey silty soil.

Figure 3.8: Soil profile from Bothkennar (UK) by Lune et al. (1997).

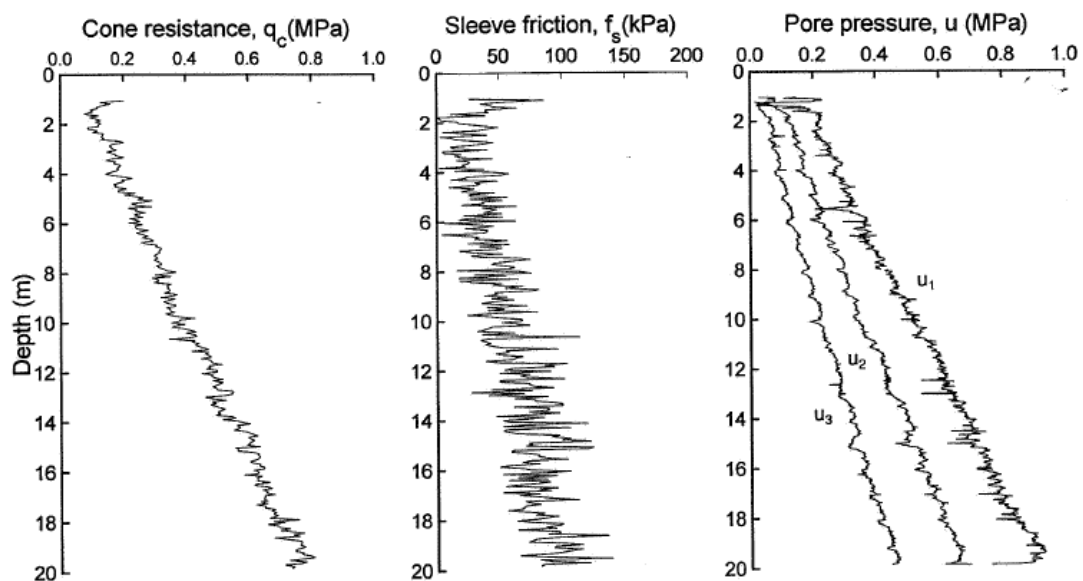
For this site Lune et al. (1997), presented a CPTu profile, with 3 piezometric elements, as shown in Figure 3.9. According to Lune et al. (1997), the pore water pressure profiles are typical of soft clay deposits.

Figure 3.9: Typical CPTu profile, Bothkennar (UK) by Lune et al. (1997).

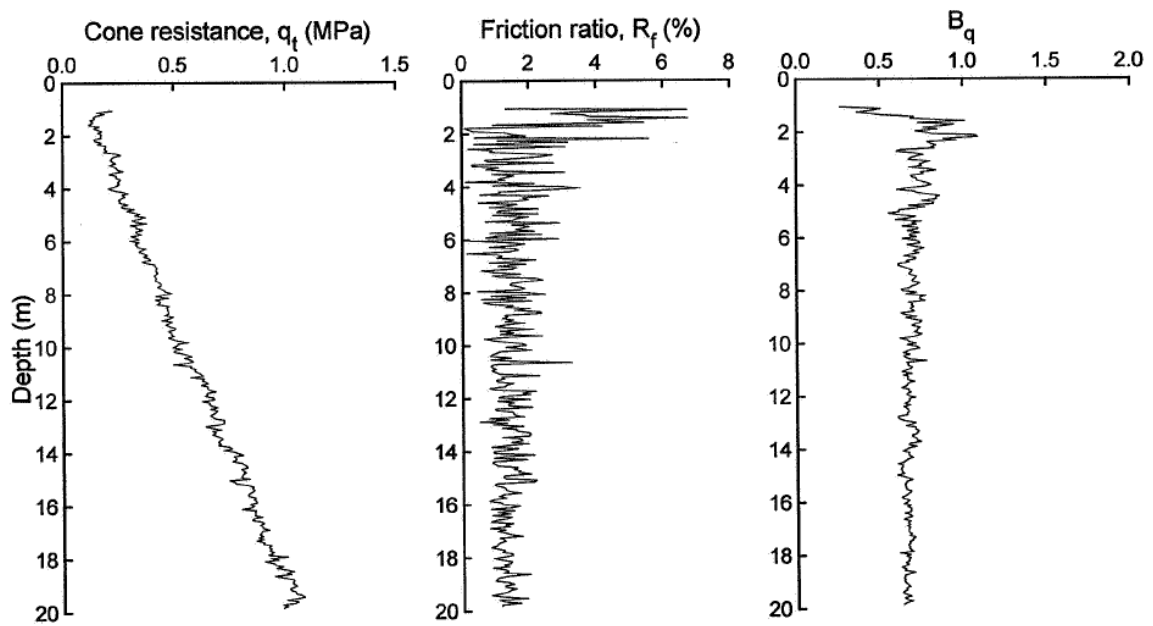
The calculated CPTu parameters are shown in Figure 3.10, the thinner variations in each profile is related to the different depositional periods. Also the q_t values are lower than 1,0 MPa, which agrees well with Table 3.2. These charts could be expressed in terms of soil parameters, for soft clays typical values of N_{kt} , N_{ke} , and $N_{\Delta u}$ of 10, 5 and 6 were chosen. A good agreement was observed between the estimated undrained shear strength, though is slightly higher than the peak strength from laboratory results (See Figure 3.11).

Figure 3.10: Derived CPTu parameters, Bothkennar (UK) by Lune et al. (1997).

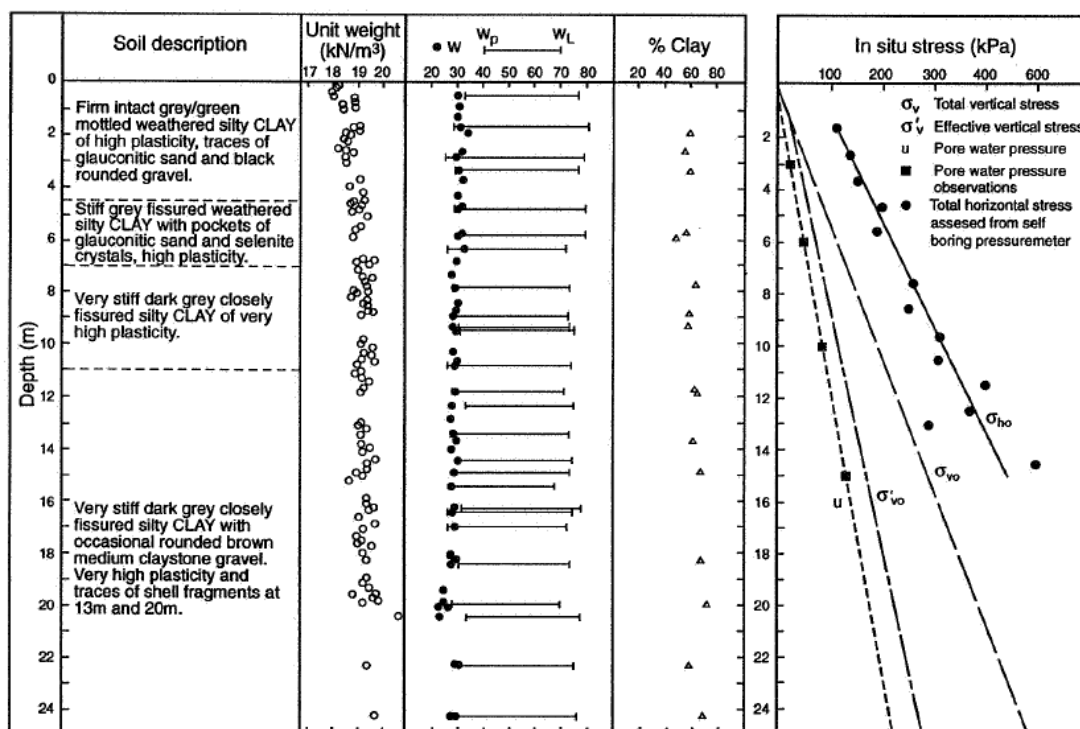
In this case study, the Gault Clay has a ground profile as shown in Figure 3.12. The first 7,0 m is a weathered, firm to stiff grey/green silty clay of high plasticity (about 50%), deeper (>7,0 m to 13, 0 m) the soil is unweathered and stiffer, densely fissured of similar plasticity. Further down, the plasticity increases, with a slightly decrease in water content, with values close to the plastic limit.

Figure 3.12: Soil profile from Madingley (UK) by Lunne et al. (1997).

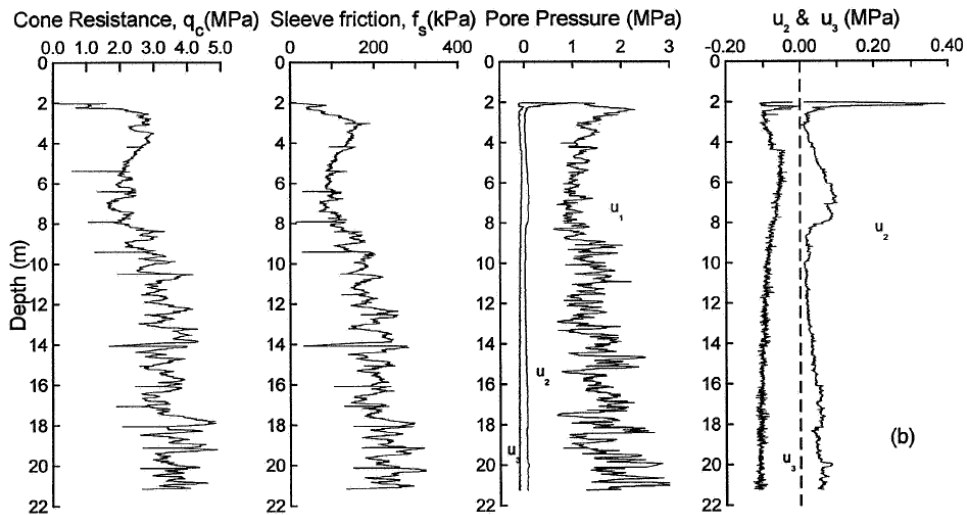
Figure 3.13, is a CPTu profile of the site, with 3 piezometric elements in locations u_1 , u_2 and u_3 . Pore water pressures at u_2 and u_3 are nearly zero, whereas u_1 is consistently showing high positive values in agreement to q_c . u_2 and u_3 , were plotted in a different graph, which confirmed that they registered very low pore pressures, representing soil behaviour at these locations.

Figure 3.13: Typical CPTu profile, Madingley (UK) by Lunne et al. (1997).

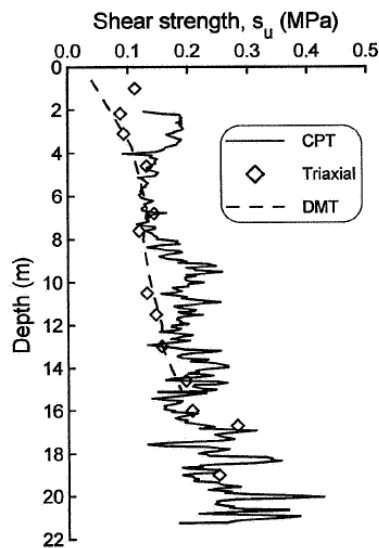
The resulting shear strength profile is shown in Figure 3.14, and it was compared to triaxial and plate load tests. Overall, the estimated values were higher due to soil fabric and scale effects, to take into account these features; Lunne et al. (1997), used N_{kt} values between 18 and 30 based on different degrees of discontinuities and q_c values. The resultant shear strength profile gave a more accurate prediction.

Figure 3.14: CPTu derived shear strength, Madingley (UK) by Lunne et al. (1997).

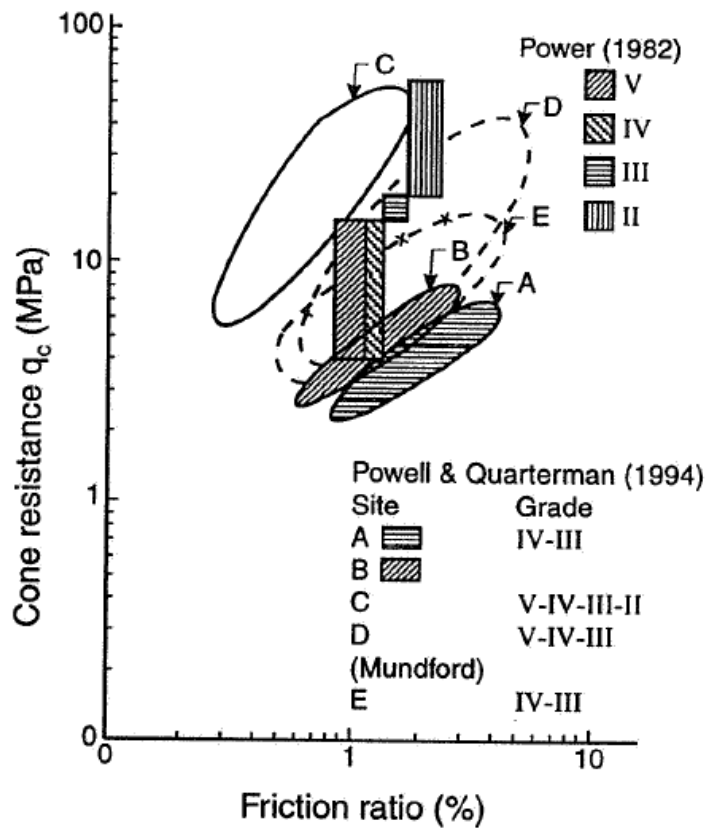
Powell and Quarterman, presented their results, including Power's ranges, as shown in Figure 3.17. From this figure it was clear that even for the CPT tests carried out at Mundford site, their data was outside Power's ranges.

Figure 3.17: Classification of Chalk grade (Powell and Quarterman, 1994).

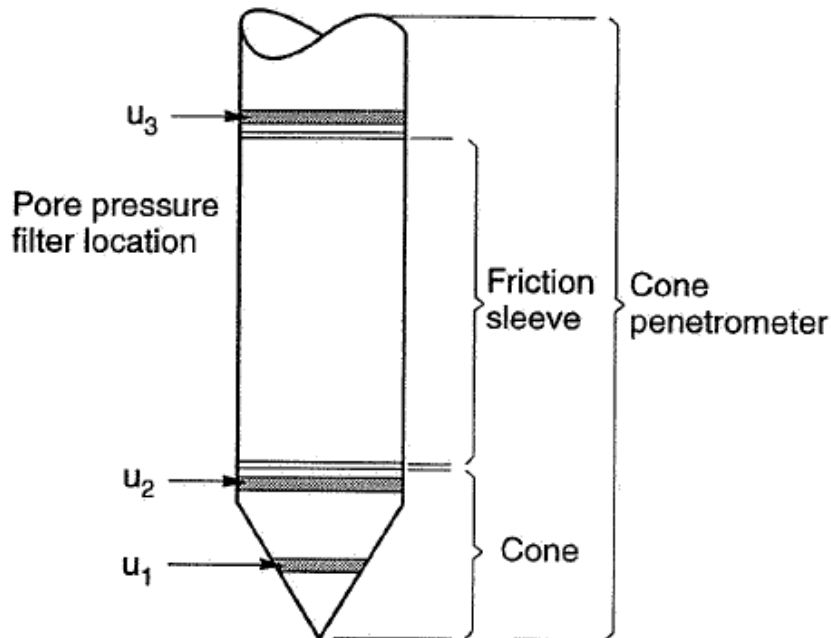
complex projects, two or three filter positions are used. Depending on the filter position, the cone tip resistance should be corrected to account for pore water pressure influence (Lunne et al., 1997).

Figure 3.18: Location of Piezometric elements in the Piezocone by Lunne et al. (1997).

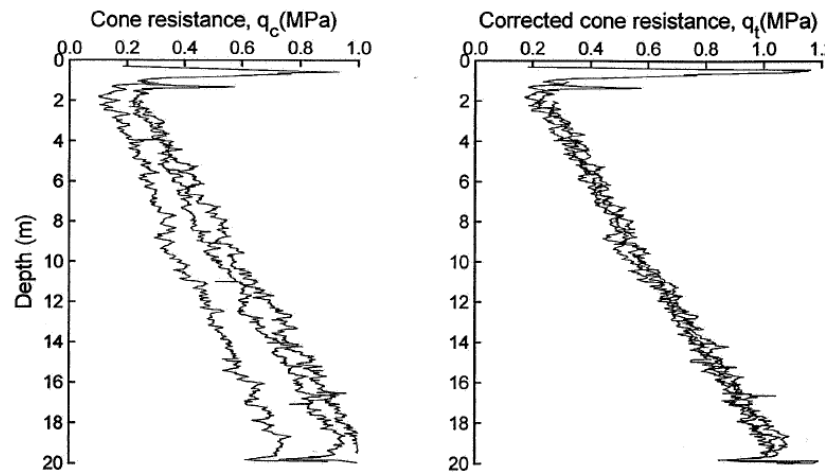
corrected profile is shown in Figure 3.20. These tests were performed with different values cone area ratios, varying between 0,59 and 1,0, at first (right) they were spread over a wide range, once corrected (left), all profiles agreed very well.

Figure 3.20: Example of the effect of correction q_c in soft soils (Bothkennar) by Lunne et al. (1997).

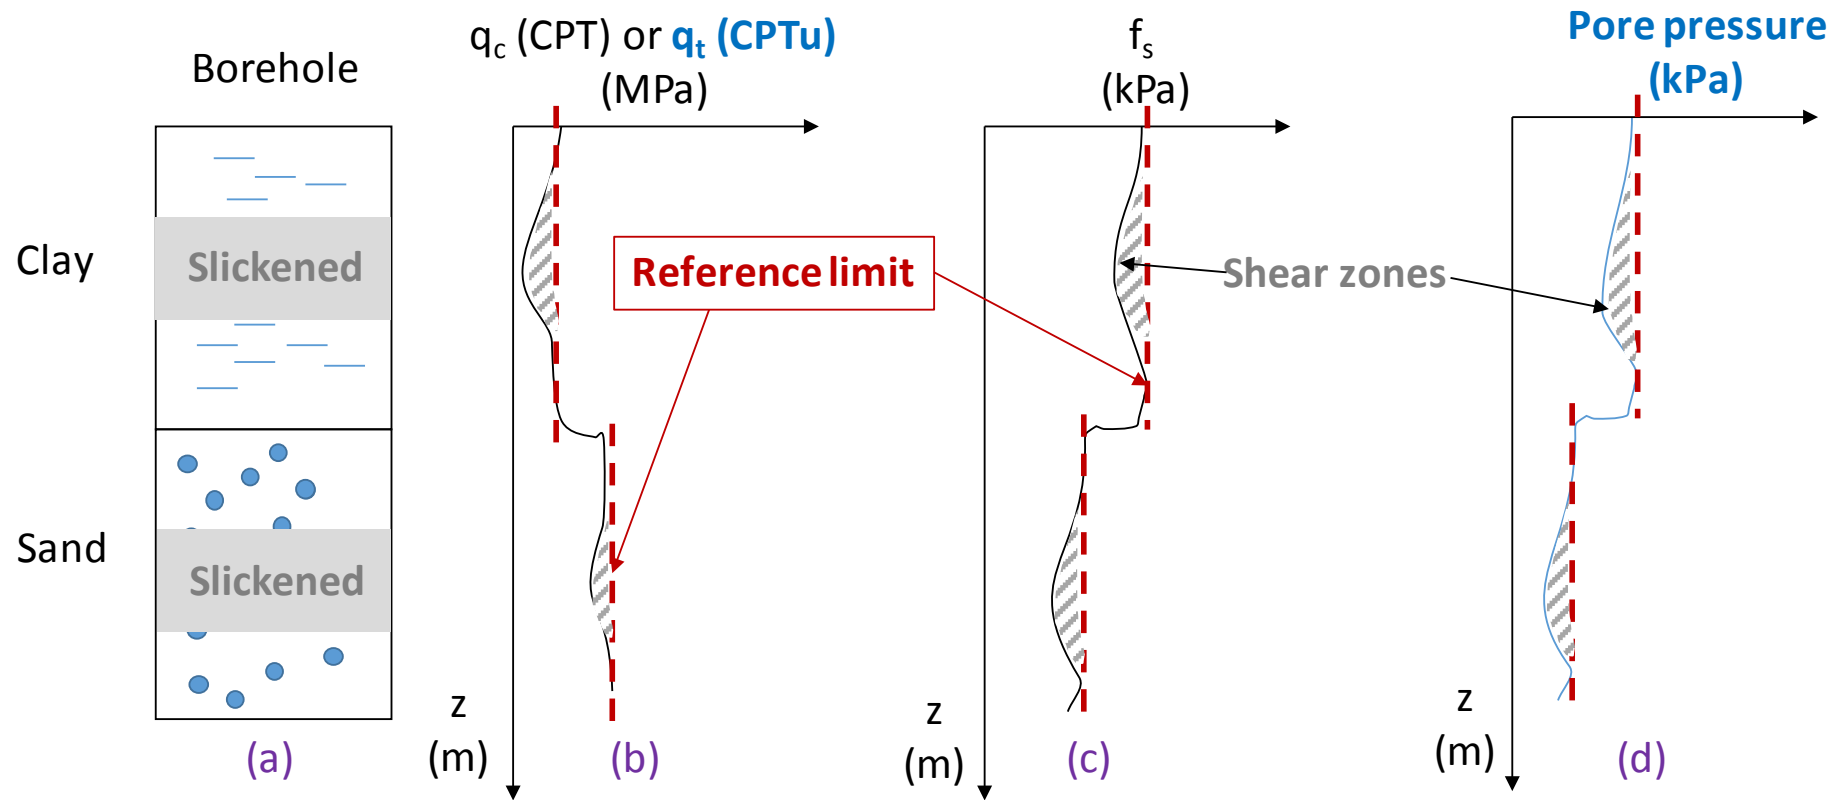
It is important to point out that the reference limits are determined considering that the geology, soil stratigraphy or soil properties, cannot change drastically in a small area. If that happens, it should be considered an indication of reworked zones or periglacial features.

Figure 4.3: Identification of shear zones

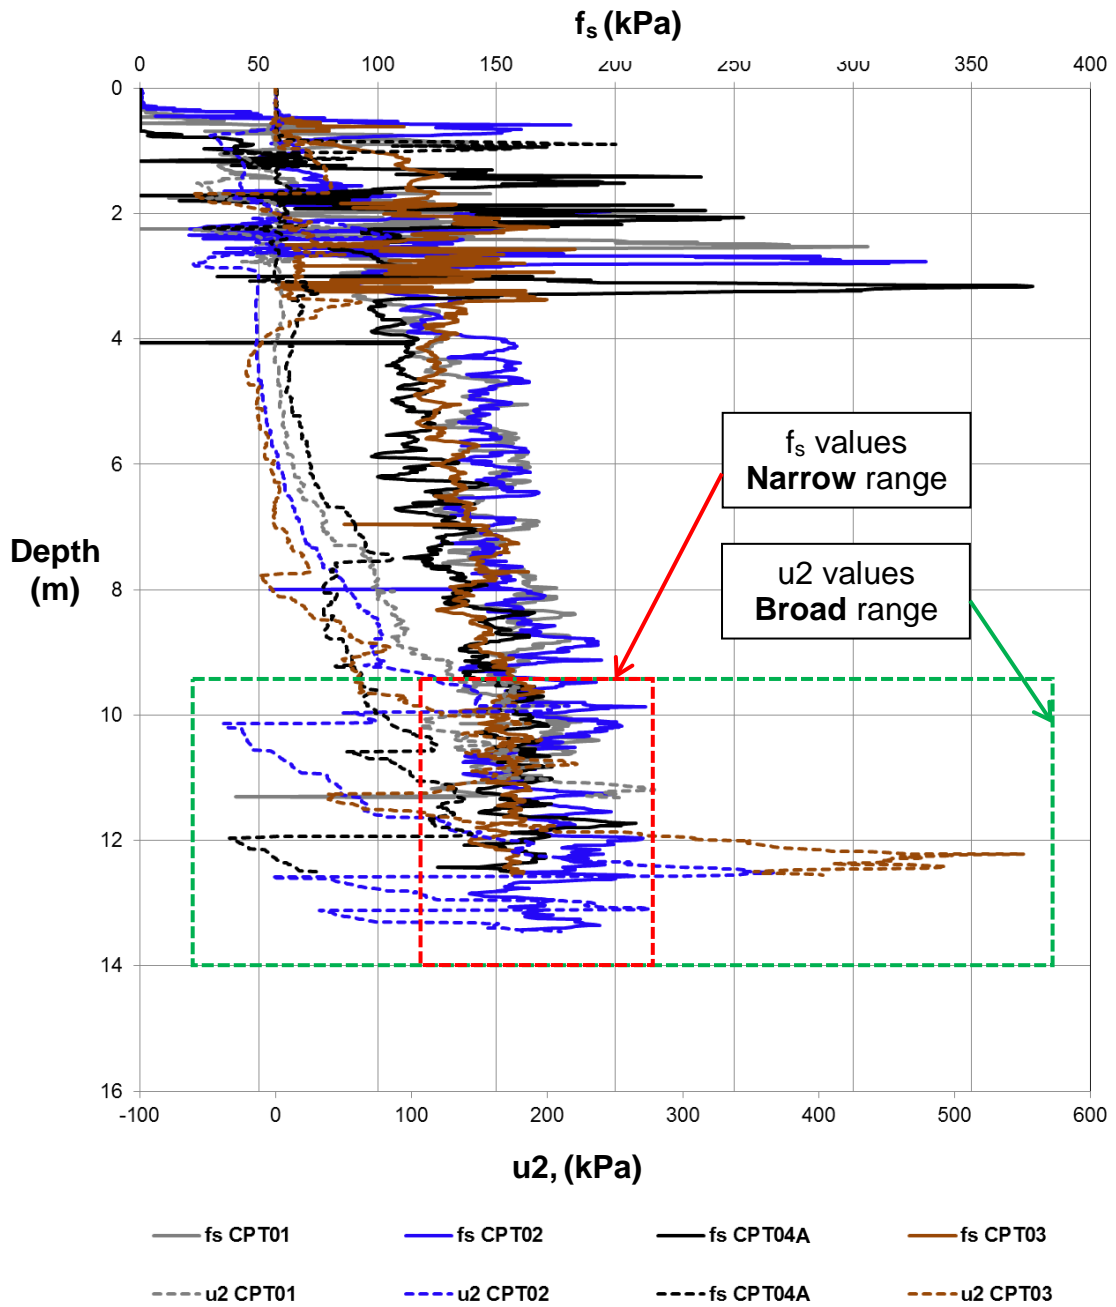
No evidence of shear zones was found, apart from the broad ranges in pore pressures that may be associated to closed fissures or changes in fines content in London Clay.

Figure 5.8: Superimposed f_s and u_2 profiles at St James's Square - Section 1.

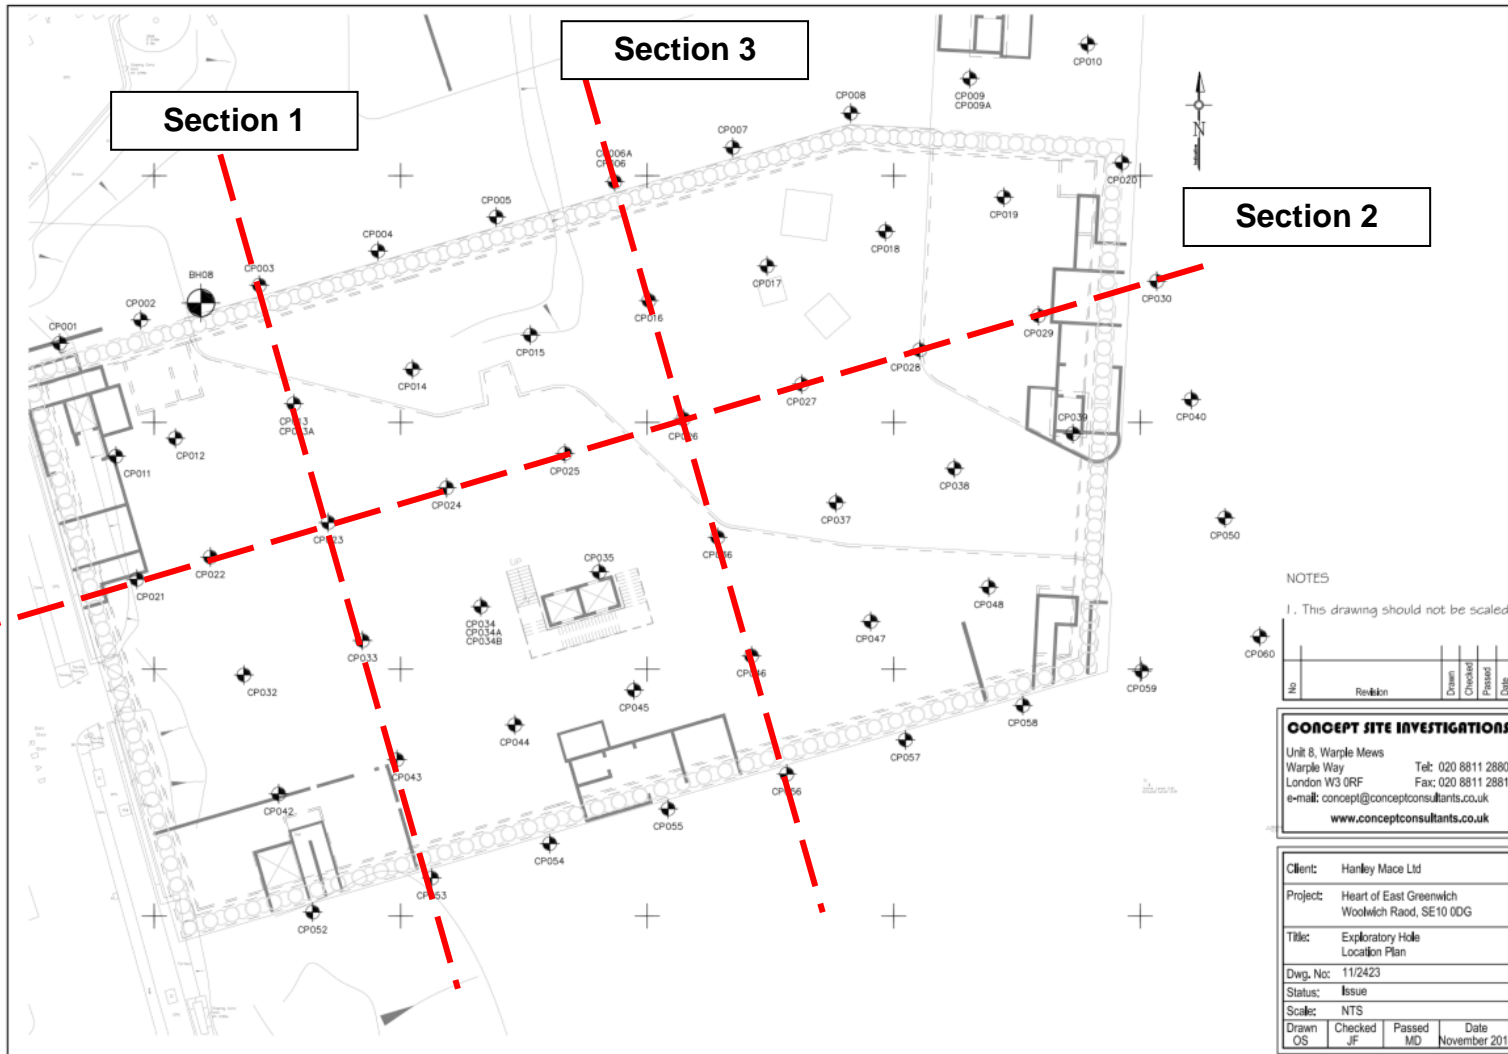
Figure 5.14: Plan view and cross sections 1, 2 and 3 at Heart of East Greenwich.

At this site, 01 borehole, 56 CPTs and 9 Piezocone tests were analyzed according to the recommended procedure in chapter 4. To analyze the existing information, 3 sections were drawn, as shown in Figure 5.14. The interpreted sections and key findings are described in the following paragraphs. The CPT and piezocone profiles were reported by Savvidou, O. (2012).

Section 2 is perpendicular to section 1 and 3. The last two are parallel to each other. Section 1 was closer to the existing borehole, and it was used to relate the CPT profile with the ground profile, as shown in Figure 5.15. This helped to have an idea of the soil layering over the site and also to aid in the interpretation of section 2 and 3.

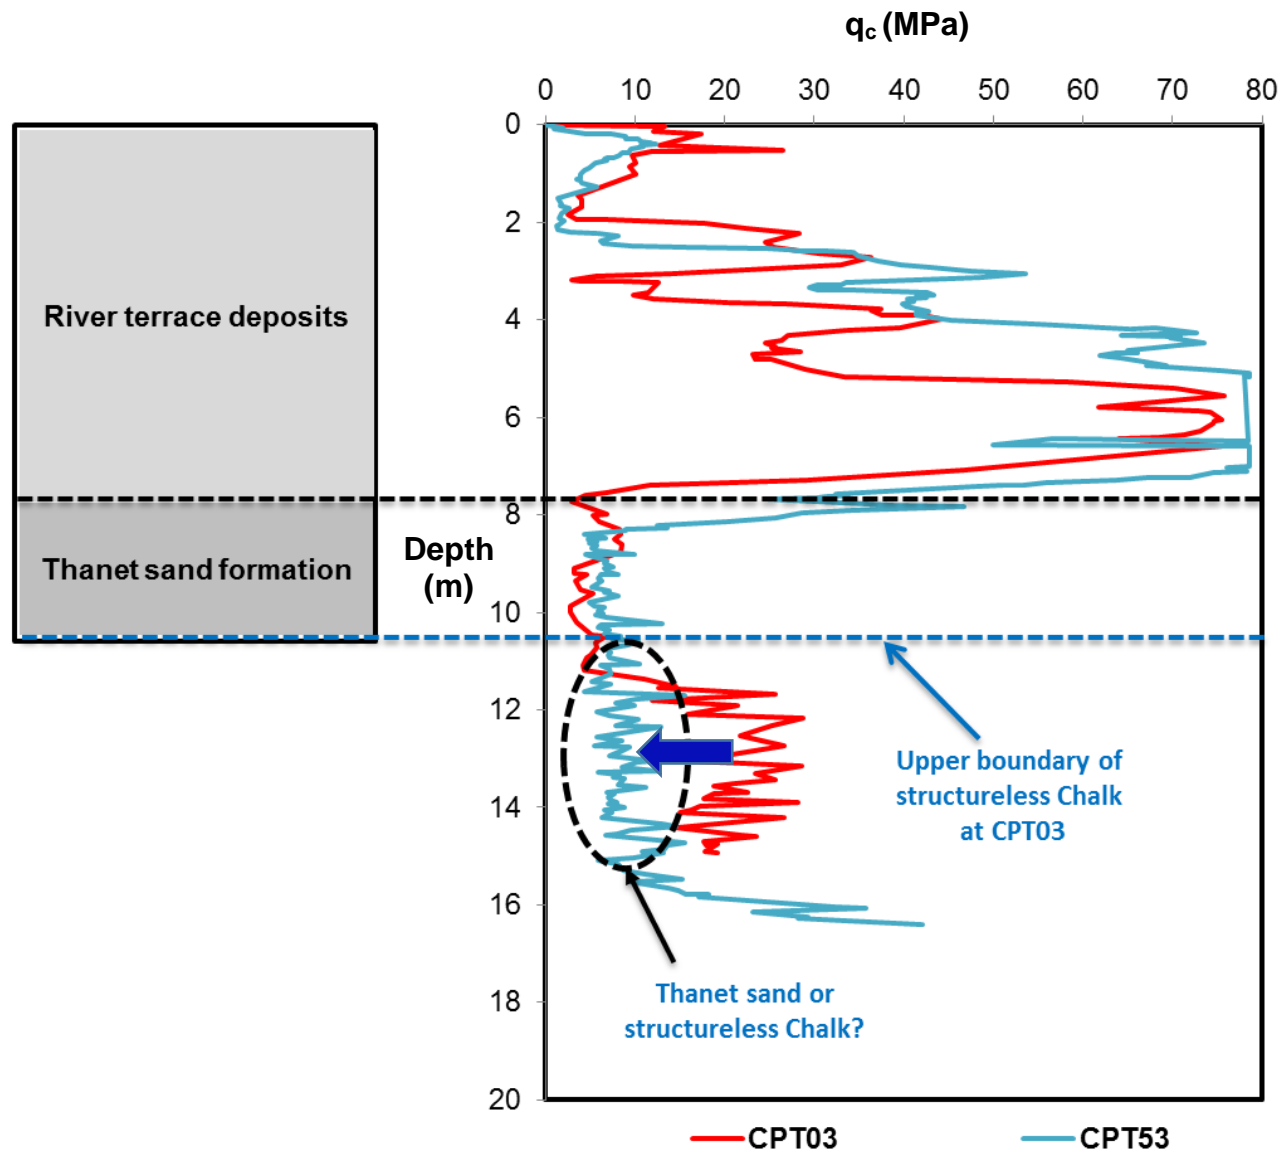
Figure 5.17: Strength variability between CPT03 and CPT53.
