***Understanding the effect of process-induced porosity on the
localized corrosion 316L stainless steel manufactured by laser
powder bed fusion***

*A thesis submitted for the degree of
Master of Professional Engineering in Chemical Engineering
May 2023*

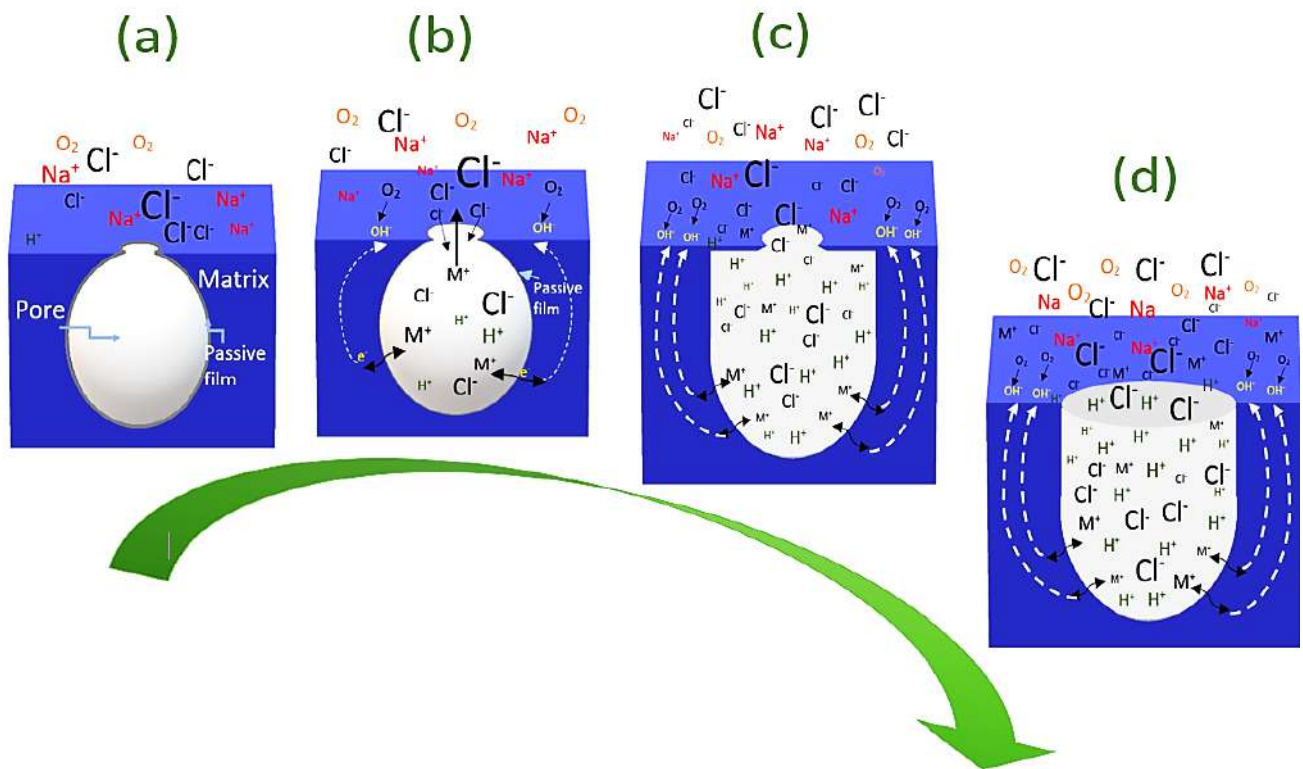
In a schematic diagram, **Fig. 2.1a** depicts the pitting mechanism induced by the manufactured gas pores of SLM 316L SS. Here metal M has a spherical shape representing

Fig. 2.1 The schematic diagram of pit formation of LPBF 316L SS exposed to aerated chloride solution

an open gas pore immersed in an aerated sodium chloride solution. Inside the pores, rapid metal dissolution occurs. In contrast, oxygen reduction occurs on adjacent surfaces, which causes the migration of chloride ions Cl^- towards the pore to balance the charge and hold electroneutrality [26], [27]. The aggressive environment inside the pore contains an excess, mainly of chloride and metal cations (Cl^- and M^+). The accumulation of the hydrogen ion H^+ inside the pit is derived from the metal cations hydrolysis. The cations concentration at the pit surface is utilized to determine the severity of the electrolytes inside the pits. Once the metal cation is higher than the critical value, the pit propagation will be maintained [24]. Electrochemical reactions are linked to the cation's concentration in SLM 316L SS. These dynamic processes occur on the surface and interior pit, where metal cations diffuse toward the bulk solution (**Fig. 2.1b**).

As illustrated in **Fig. 2.1d**, the active state dissolution increases the transfer between the gas pore and the matrix with or without cover. According to the pitting corrosion framework provided by Frankel *et al.* [17], ongoing pit formation occurs when the active dissolution rate is more major than the diffusion rate in the matrix, maintaining so the cation

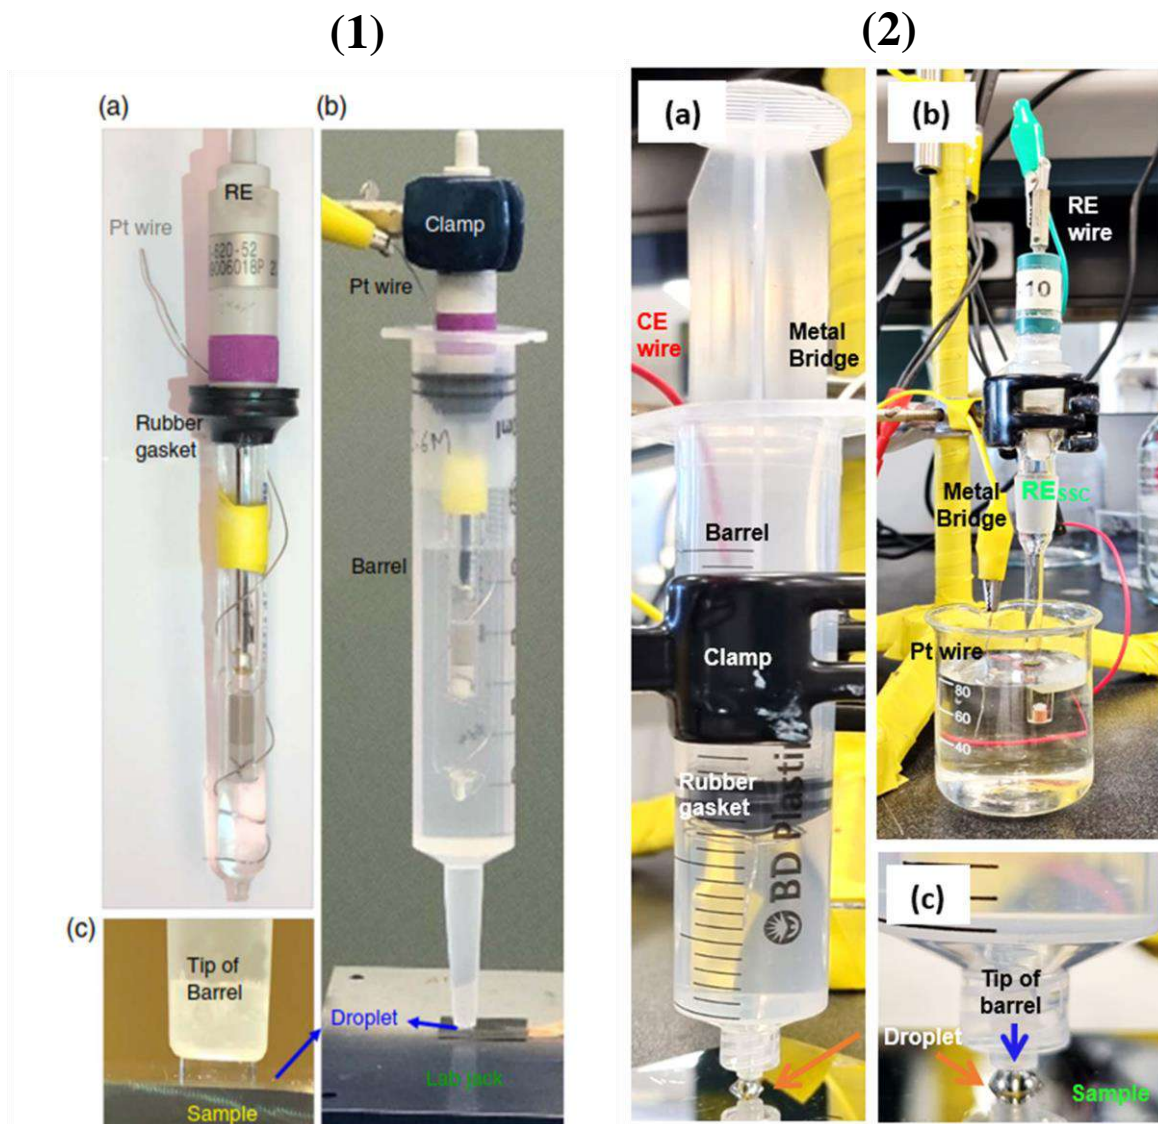
As a result, the syringe cell is one of the most convenient methods that minimize the drawbacks mentioned above. The setup of the syringe cell method (**Fig. 3.1-1**) includes the following features: test solution, reference electrodes, and counters. By pushing the tip of the syringe against the sample surface, direct contact of the electrolyte with the sample surface in a precise spot for electrochemical signal data (**Fig. 3.1-1b,c**). This approach, however, has practical constraints, such as the influence of capillary size on current restriction, leakage, or microcapillary tip obstruction [45], [46]. Hence, to prevent this sort of issue, the tests were performed using a short period of potentiodynamic scanning. This approach helps mitigate the potential impact of droplet size fluctuation between the test surface and syringe tip over time, which could be caused by factors such as evaporation or another characteristic [47], particularly when operating at room temperature.

The experimental setup for this study involved modifying the methodology proposed by Panindre et al.[48] as indicated in **Fig. 3.1-2**. In **Fig. 3.1-1b**, the reference electrode was used directly, which increased the syringe weight and made the control of waterdrop at the barrel tip difficult. Additionally, considering the recommendations made by Choudhary *et al.* [49], contamination of the test solution often encountered when using porous frits or salt bridges. Thus, a metal bridge of platinum was introduced, effectively eliminating the risks and issues and ensuring the integrity and reliability of the experimental results [49]. A schematic diagram of the syringe cell used in this work is shown in **Fig. 3.2**.

Fig. 3.1 Description of syringe cell setup 1) Method proposed by Panindre [48]. 2) An enhanced syringe cell incorporating a metal bridge.

electrode (see **Fig. 3.1-2b**), and a copper wire was soldered to the back of the specimen to establish electrical contact, **Fig. 3.2**.

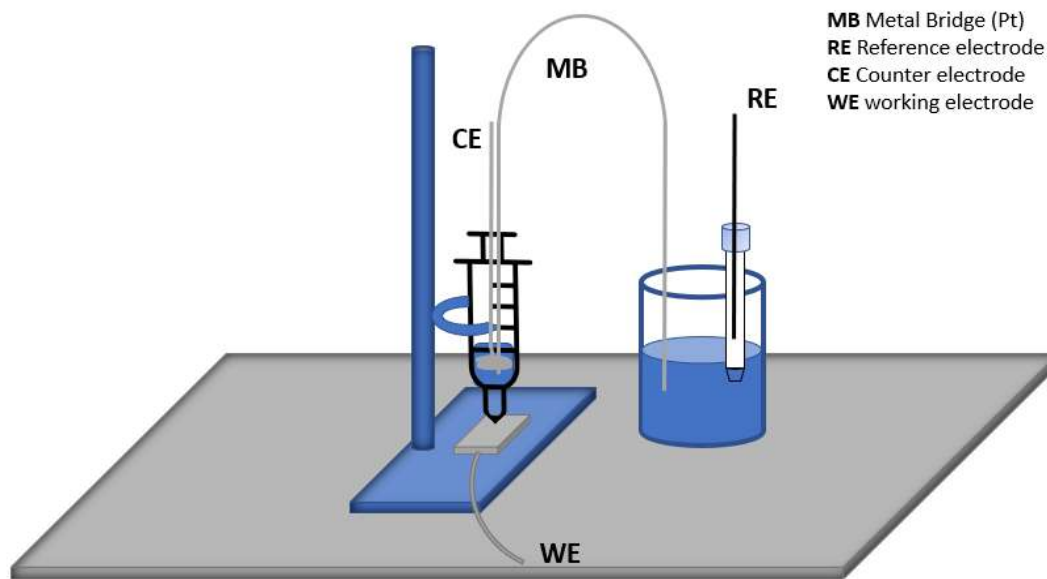
Fig. 3.2 Schematic diagram of syringe cell incorporating a metal bridge used in this experiment.

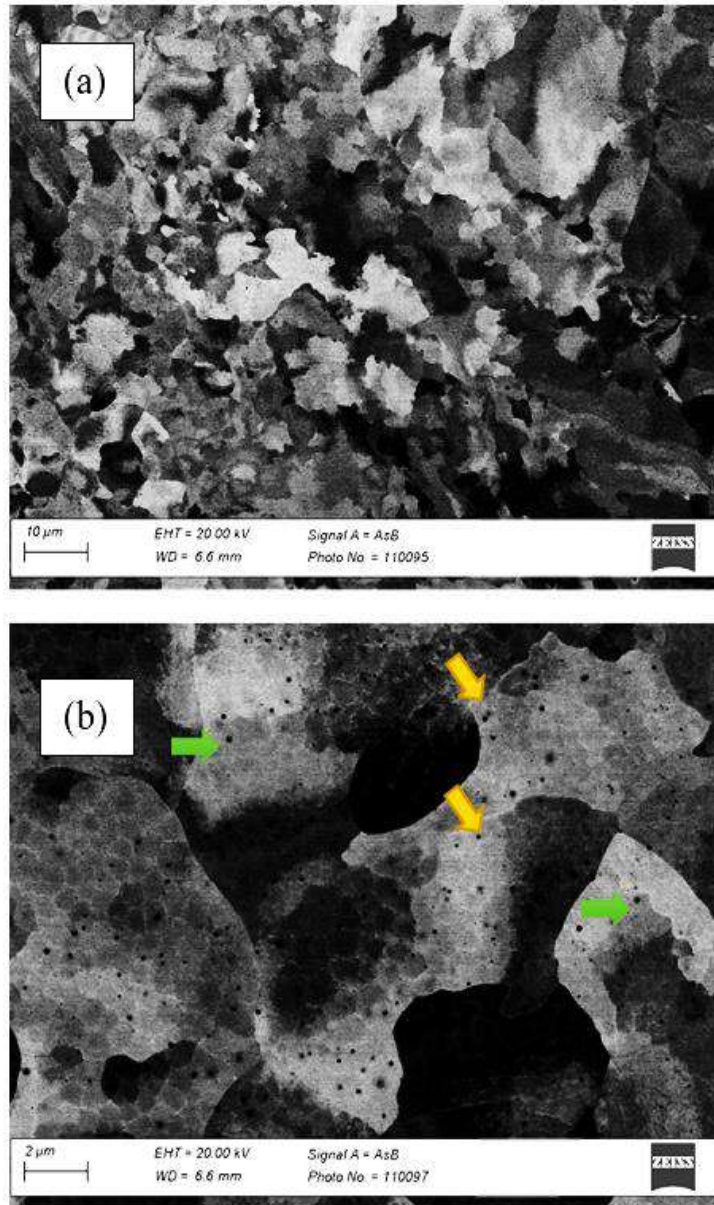
The backscattered SEM of LPBF 316L SS are shown in **Fig. 4.1a** confirms the presence of a fully austenitic single phase structure, which is in good agreement with other studies [3], [30], [33], [50]. Upon higher magnification **Fig. 4.1b** the SEM image unveils the presence of nano inclusions and cellular network dispersed throughout the microstructure. These features as indicated by arrows in **Fig. 4.1b**, consistently align with prior studies [3], [30], [51]. These nano inclusions and cellular networks can arise during the LPBF process and may have implications for the material's properties, such as mechanical strength and corrosion resistance [8], [13], [50].

Fig. 4.1 Scanning electron microscope (SEM) of LPBF 316LSS shown the microstructure of the specimens (a, b). The green arrows refers to the nano inclusions and the yellow ones refers to the cellular networks.

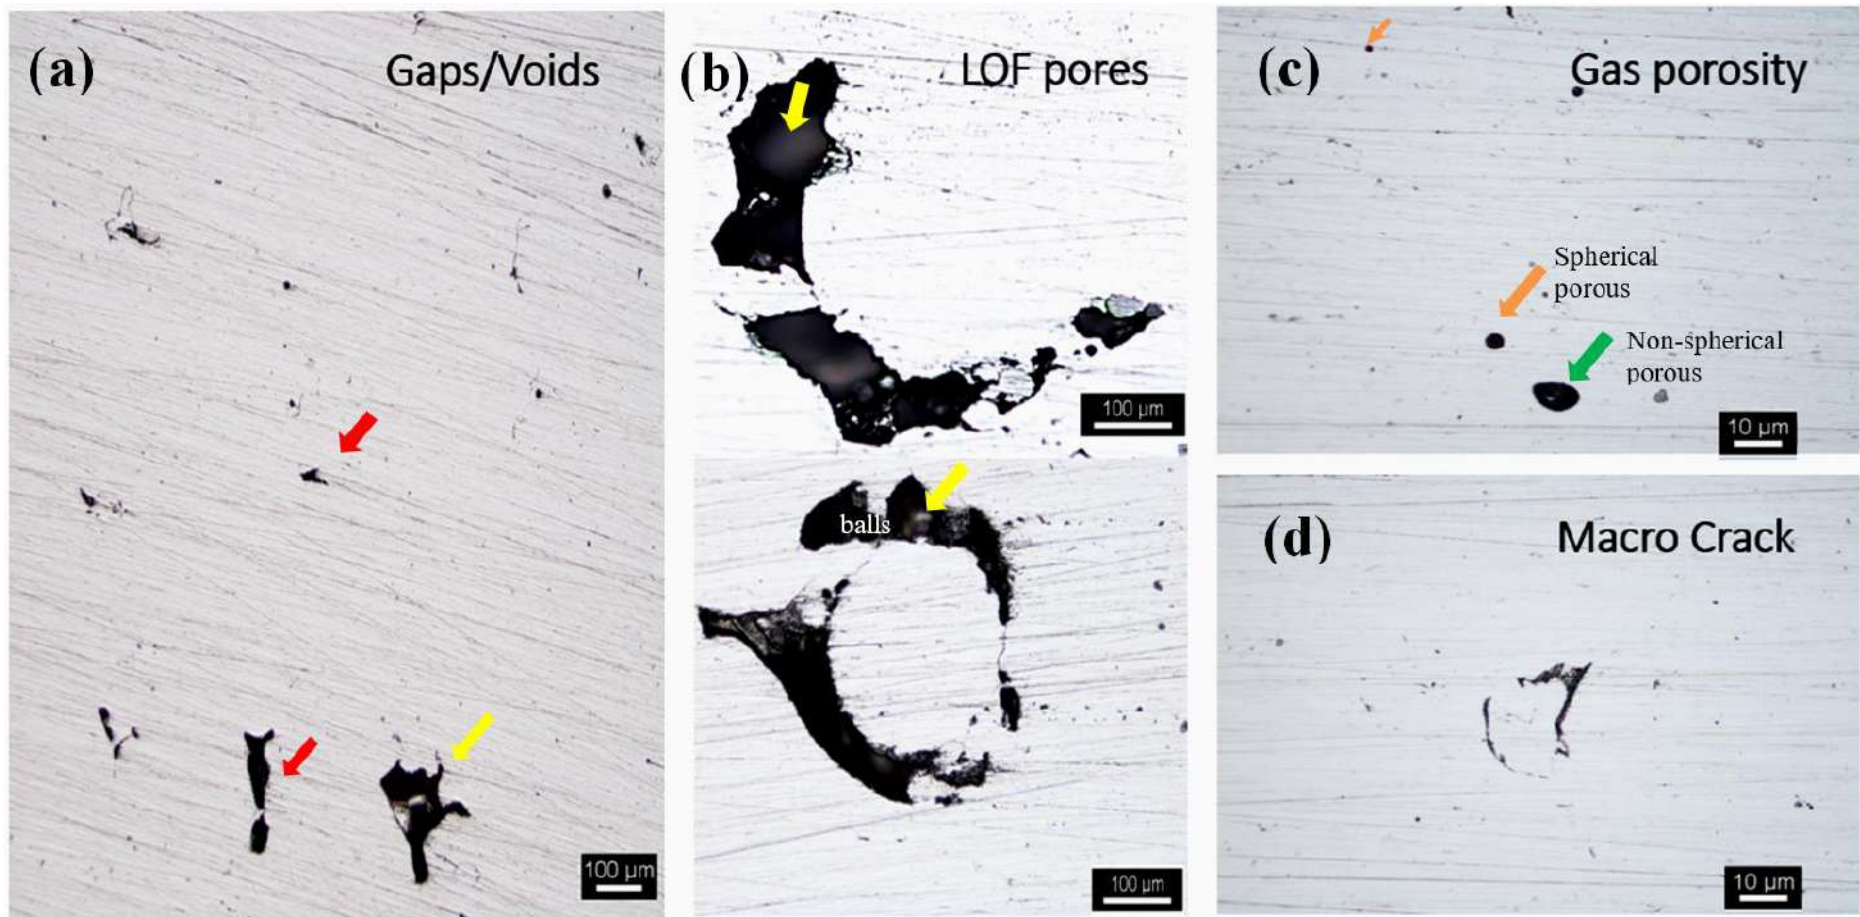
Fig. 4.2 illustrates the defects observed in 316L SS LPBF specimens using a light optical microscope (**LOM**). A prominent characteristic observed in all specimens is the presence of porosity, indicating that the samples are not completely dense [7]. The defects detected include micro cracks, gaps, voids and lack of fusion pores (LOF). It is worth noting that in this area, microcracks were consistently observed, which could be formed during the solidification around the boundaries of the melt pools.

The evaluation of LOF (lack-of-fusion) porosity area, referred to incomplete fusion between adjacent powder particles and the substrate during the laser powder bed fusion (LPBF) process, revealed the presence of small balls measuring approximately 30 μm within the LOF porous regions. The presence of lack-of-fusion (**LOF**) pores, **Fig. 4.2b**, is often attributed to the application of lower LPD, resulting in penetration depth and melts pool, leading to cone-shaped melt pools. In contrast, higher LPD [38], [69], [70] and higher LSV [61], [62], [68] can cause insufficient melting, contributing to the formation of LOF pores irregular polygonal-shaped porosity at the inter-layer boundaries [12], [31], [58], [71]. Lower LPD impacts the penetration depth and melts pool, leading to cone-shaped melt pools. In contrast, higher LPD [38], [69], [70] and higher LSV [61], [62], [68] can cause insufficient melting, contributing to the formation of LOF pores.

Fig. 4.2 The defects in the 316L stainless steel (316LSS) specimens fabricated using laser powder bed fusion (LPBF) were identified using a light optical microscope (LOM). The red arrows refers to the gaps, the yellow refers to the LOF pores , the orange to the spherical porous and the green to the non-spherical porous.

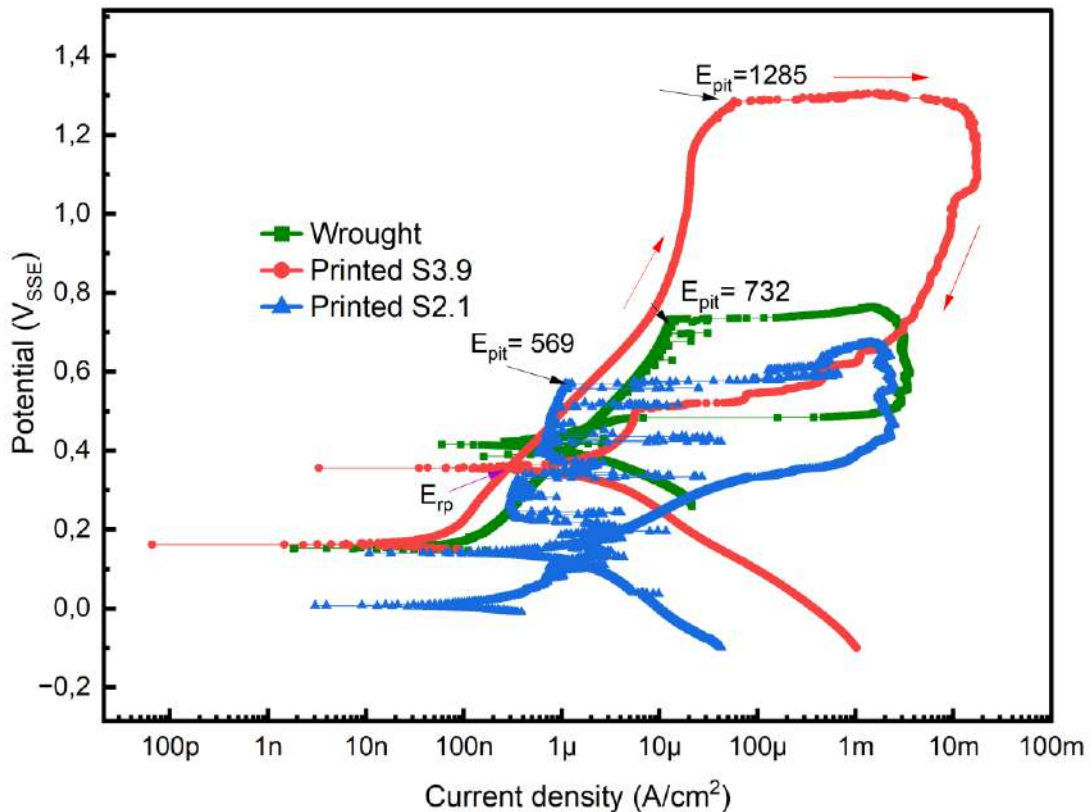
It needs to mention that the CPP curve of sample PS2.1 during the forward scan showed fluctuations, indicating the occurrence of metastable pitting. Similar behavior has been reported in both printed manufactured components [3] and their counterparts [72], [73]. The

Fig. 4.3 Metastable pitting behavior of individual specimens in Wrought 316l stainless steel and printed specimens.

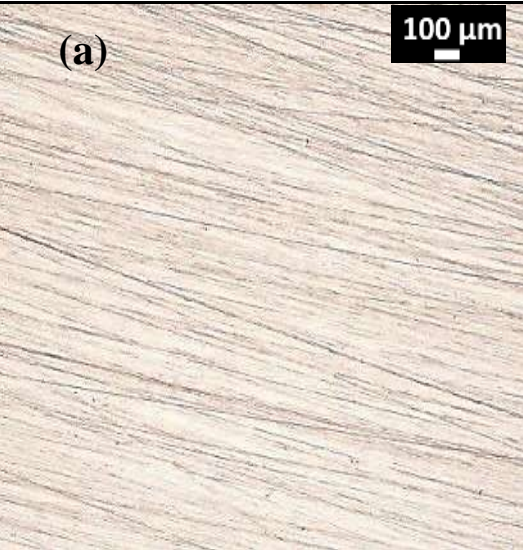
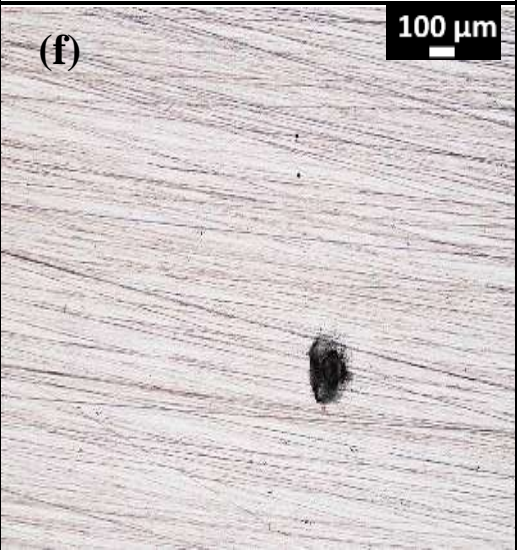
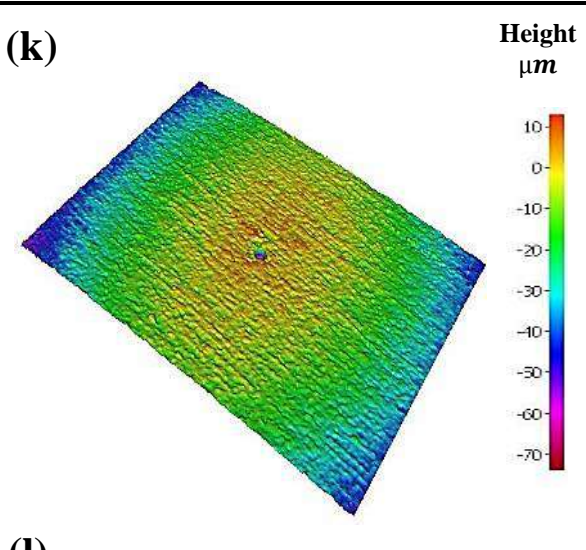
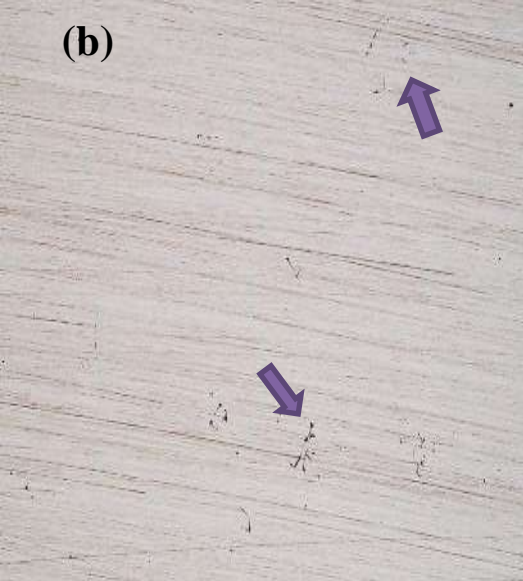
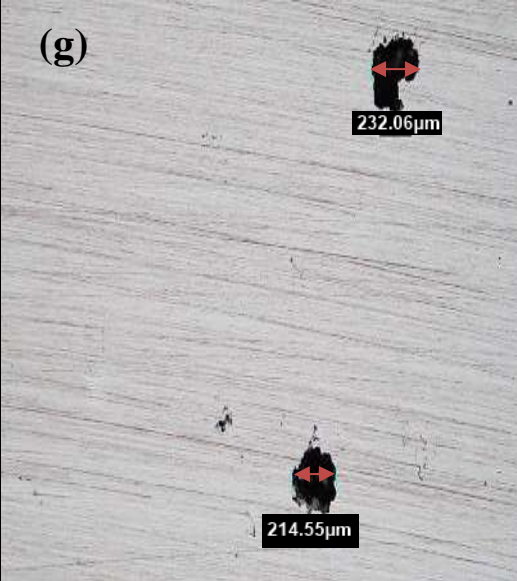
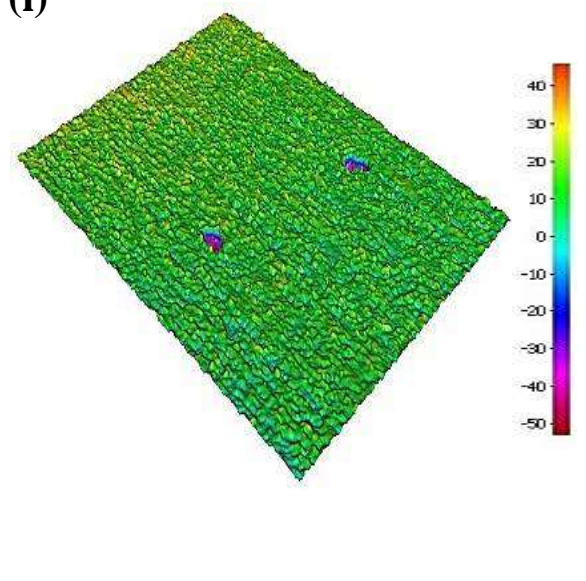
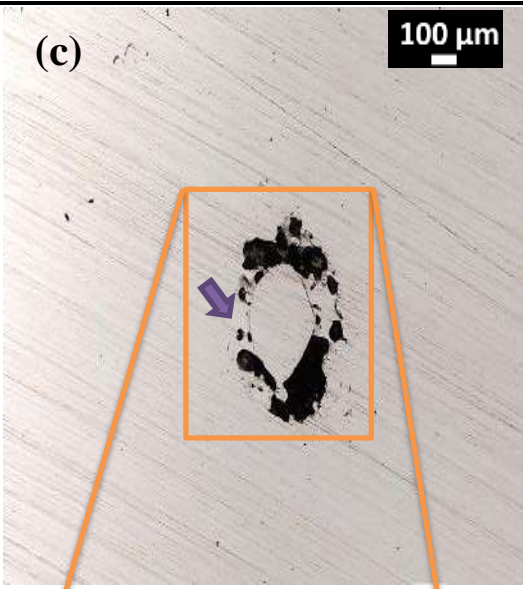
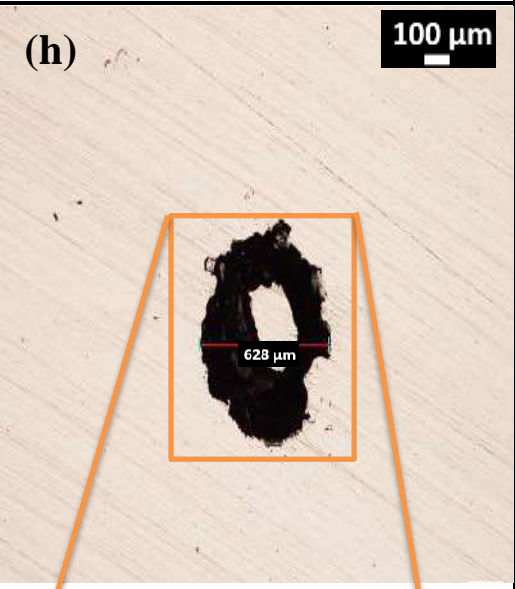
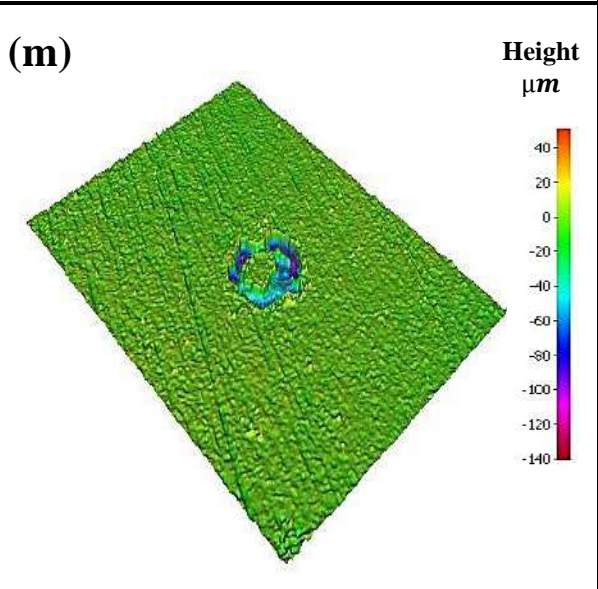
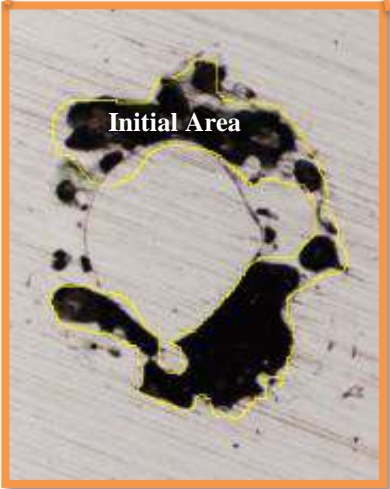
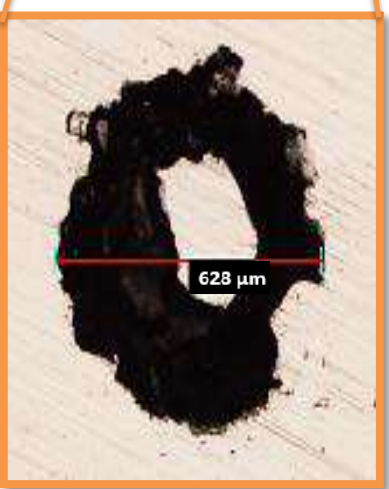
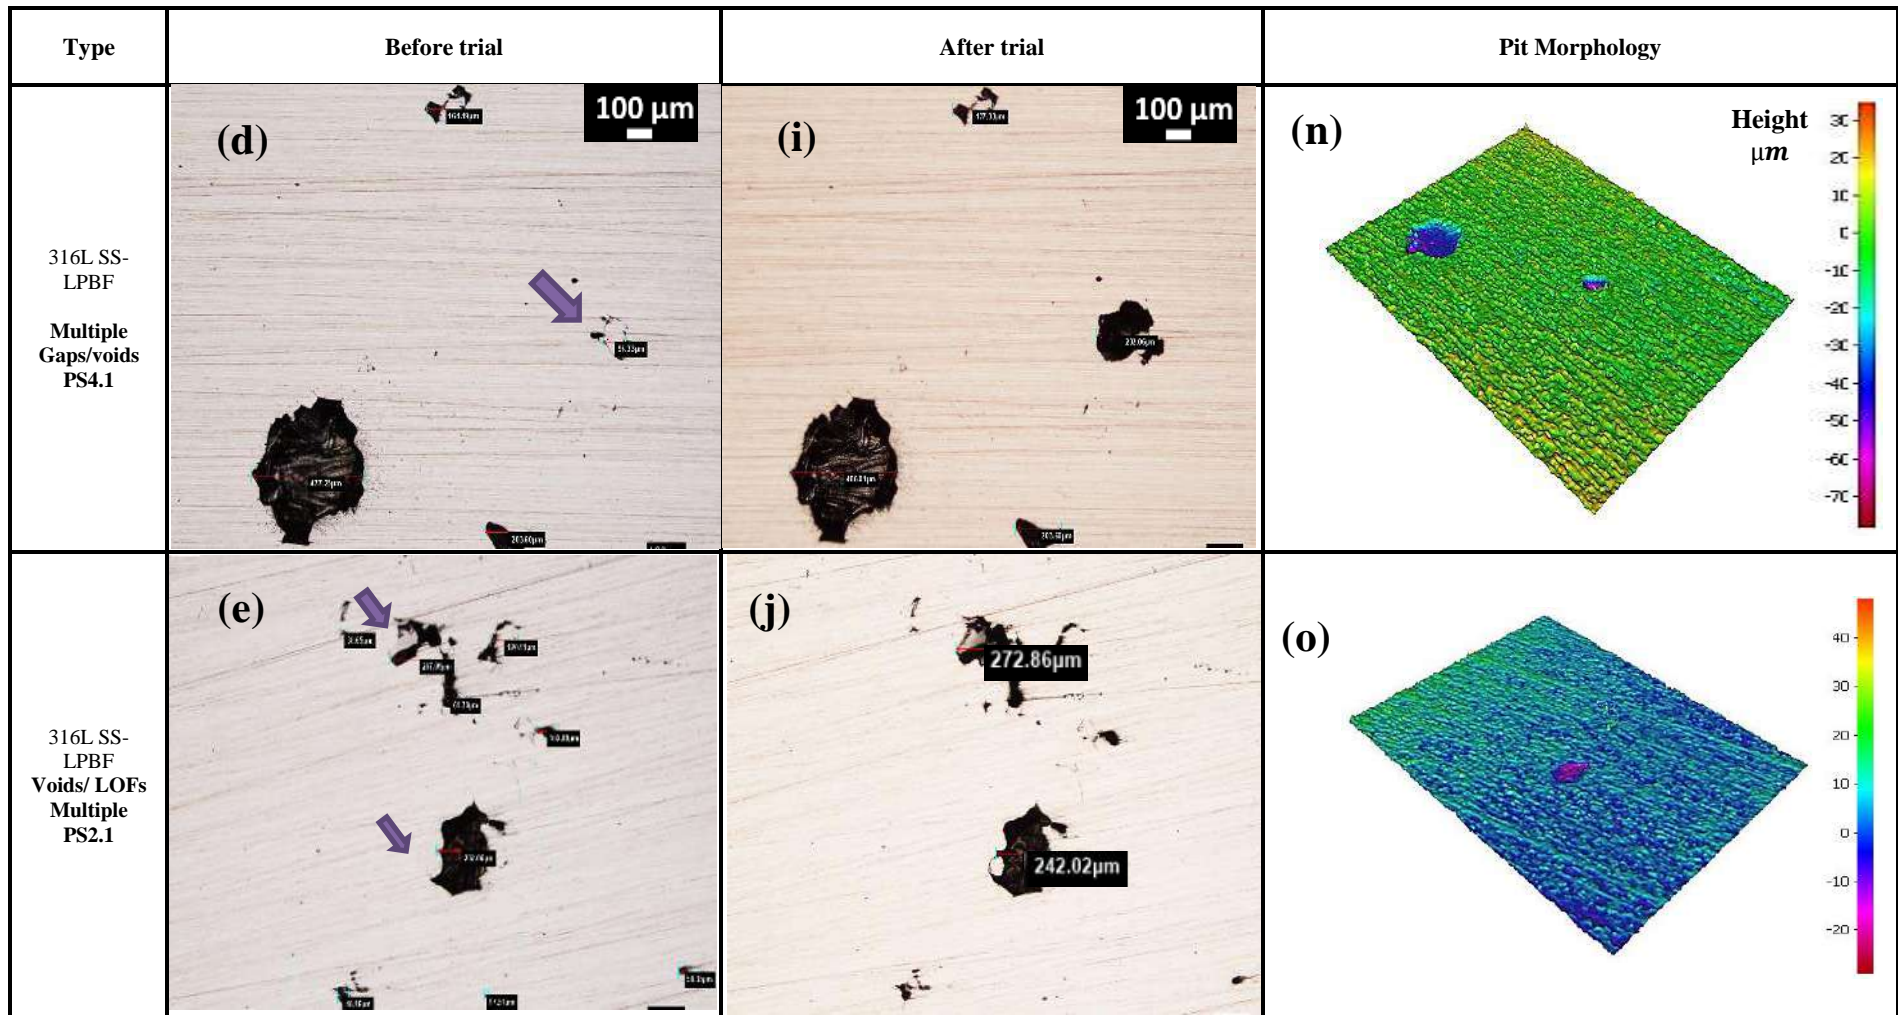
Type	Before trial	After trial	Pit Morphology
Wrought 316L SS	<p>(a)</p>

316L SS-LPBF Defect: Microcracks PS3.2	<p>(b)</p>

Type	Before trial	After trial	Pit Morphology
316L SS-LPBF Defect: LOF PS3.9	(c)

Fig. 4.4 The morphology of the wrought and 316L stainless steel (316L SS) LPBF specimens before and after the test. The figure provides visual representations of the specimen surfaces, illustrating any changes in morphology due to the testing process. The comparison between the pre-test (a-b) and post-test (f-j) and images of the pit (k-o) allows for a better understanding of the structural alterations that occurred during the testing of LPBF specimens.

It is worth noting that the evaluated LOF porosities were either isolated or in close proximity to voids, as depicted in **Fig. 4.4c, d**. Additionally, it is observed that the size of lack of fusion (LOF) defects did not significantly impact the pitting potential. However, the sample with multiple defects (PS2.1) exhibited a considerably lower E_{pit} value, suggesting a heightened susceptibility to pitting corrosion, **Fig. 4.5**.

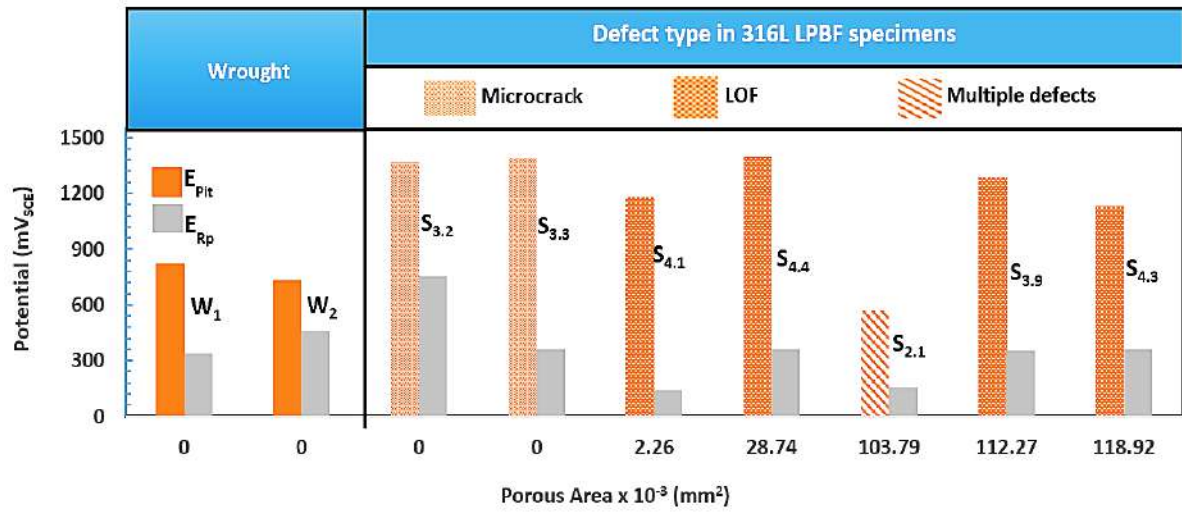
The summarized results of the pitting potentials (E_{pit}) and repassivation potentials (E_{rp}) for different types and sizes of porosities in **Fig. 4.5** have revealed interesting findings. Samples with micro cracks (PS3.2 and PS3.3) exhibited higher E_{pit} values, indicating increased

resistance to pitting corrosion compared to their 316L SS counterparts. This observation is consistent with previous literature on LPBF 316L SS [3], [30], [34], [51]. Similarly, samples with lack of fusion defects (LOF) demonstrated higher E_{pit} values than wrought counterpart, albeit slightly lower than LPBF 316L SS with micro cracks.

Fig. 4.5 Correlation between potential values and porous area in tested specimens

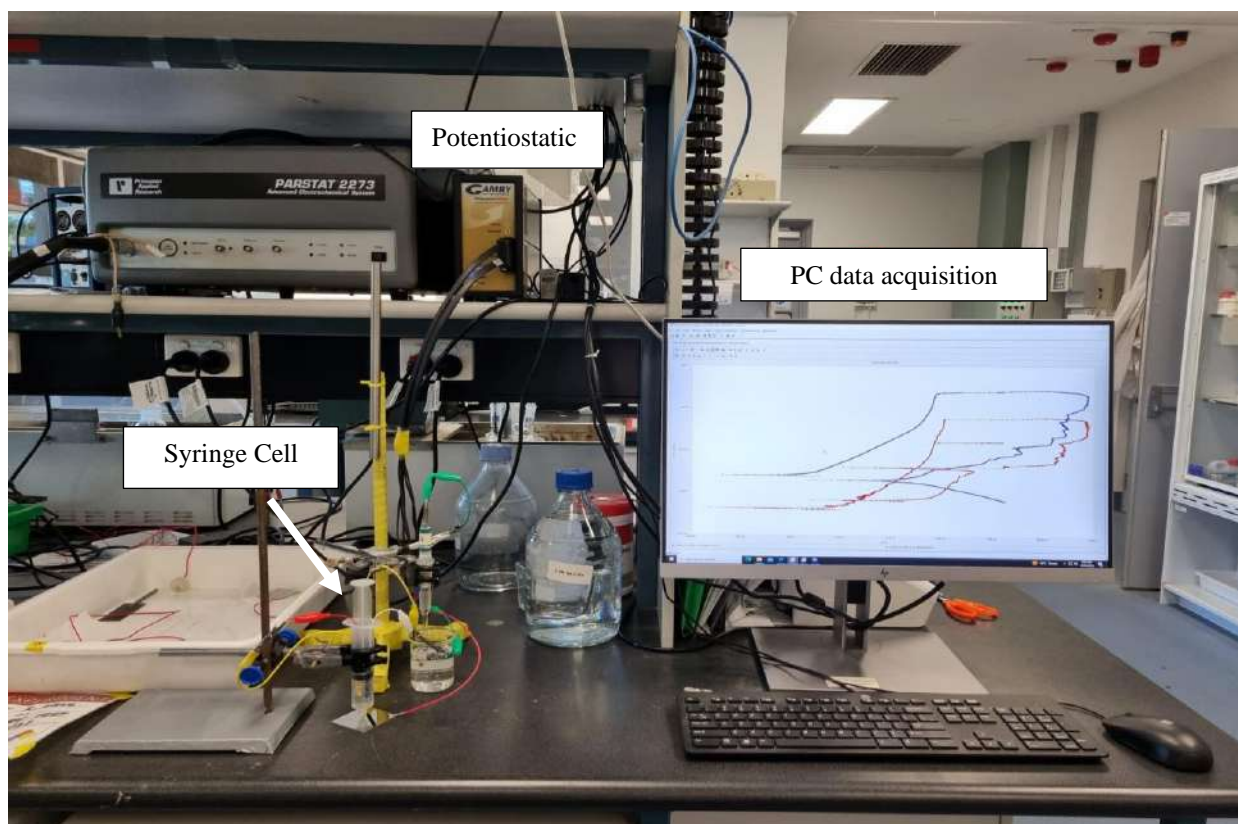
Fig. 6.1 Syringe cell configuration located in the laboratory of Curtin Corrosion Centre.
